SATELLITE 9443
DSCS II ANOMALY REPORT
NARROW COVERAGE DOWNLINK NOISE

14 AUGUST 1981

Report No. 36060-AR-024-01
CDRL No. 009A3
F04701-80-C-0022

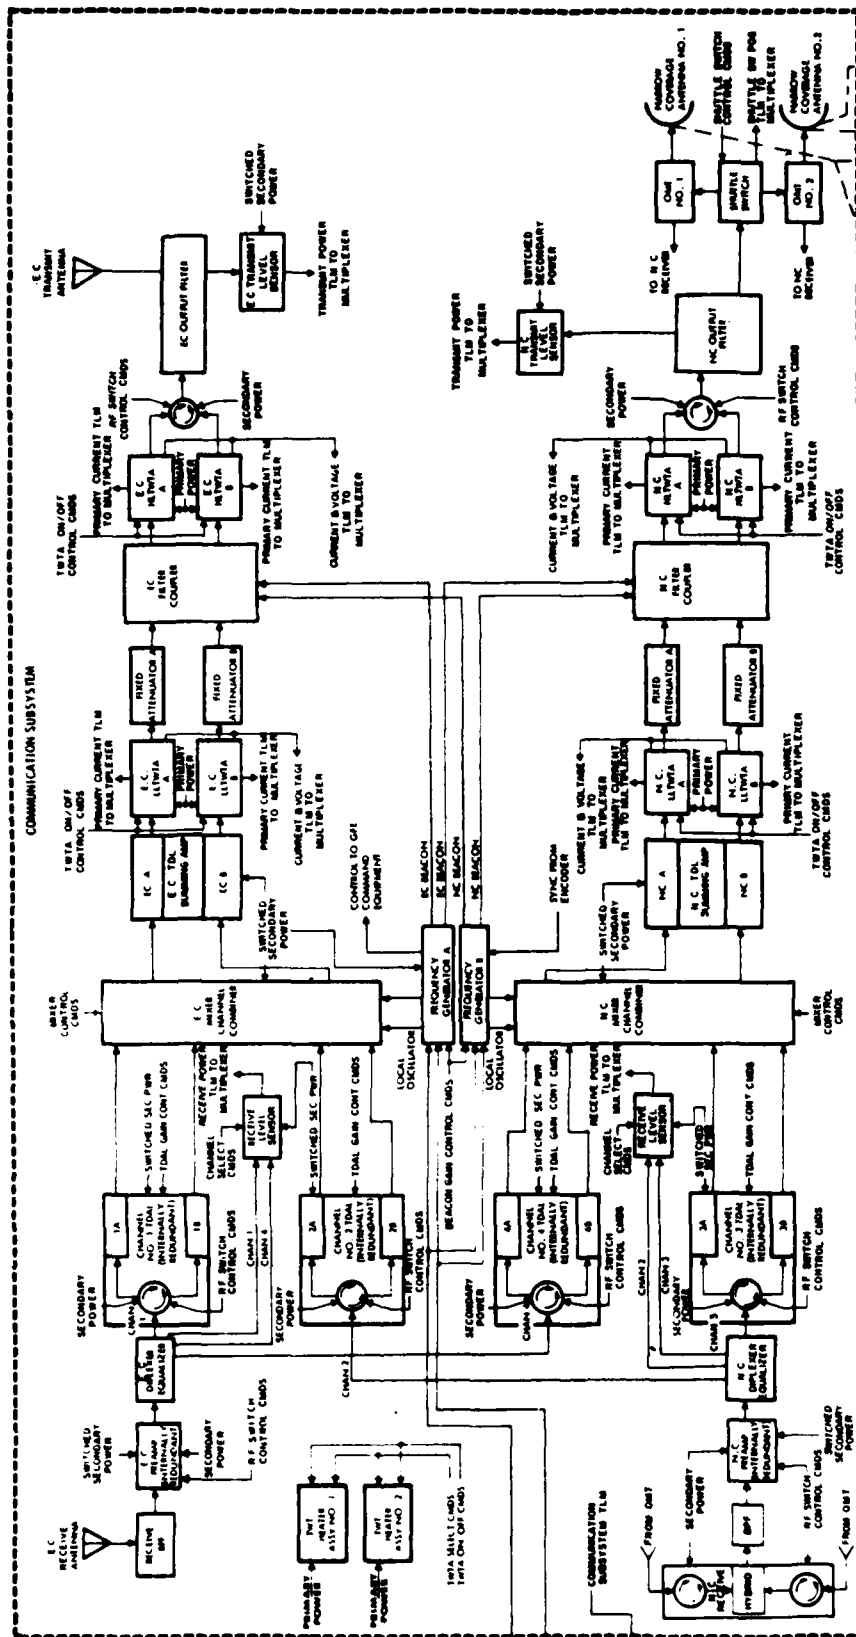
Figure 1.1-1. DSCS II Communications Subsystem Block Diagram

Figure 1.1-1 shows a block diagram of the communication transponder and Figure 1.1-2 shows an expanded version of the transmitter section. Study of these block diagrams shows that a number of possible sources exist to cause an RF spike on the narrow coverage output. By performing a series of on-orbit tests, described in Section 3.1, the primary cause was narrowed down to the HLTWTA, with a very remote possibility of the LLTWTA or TDSA. Ground testing at Hughes Electron Dynamics Division (HEDD), as described in Section 3.2, was able to reproduce the on-orbit anomaly signature by causing arcs to occur in the cathode circuitry. Analysis of all test data, as described in Section 4.0, led to the conclusion that the RF spikes were caused by an arc occurring in a relatively high vacuum (10^{-5} Torr) from a wire in the cathode circuit of the tube to the end of the TWTA housing. The arc did not occur in any potting material.

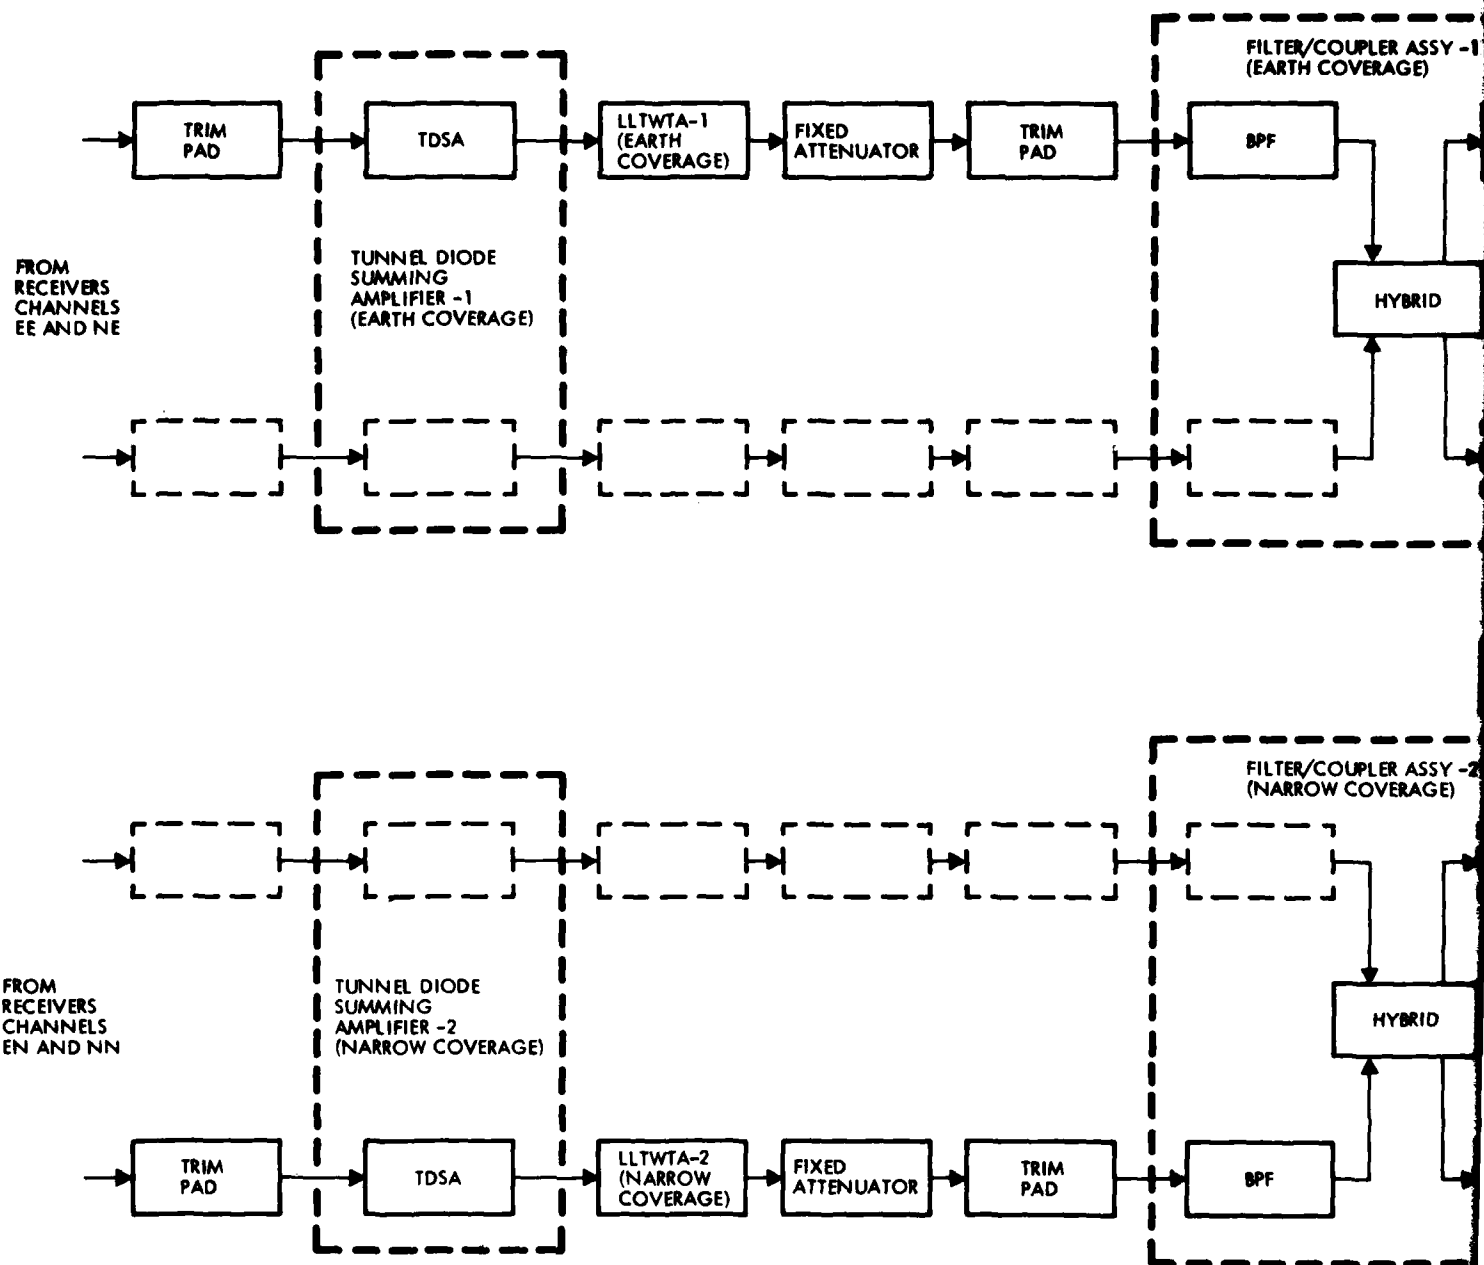
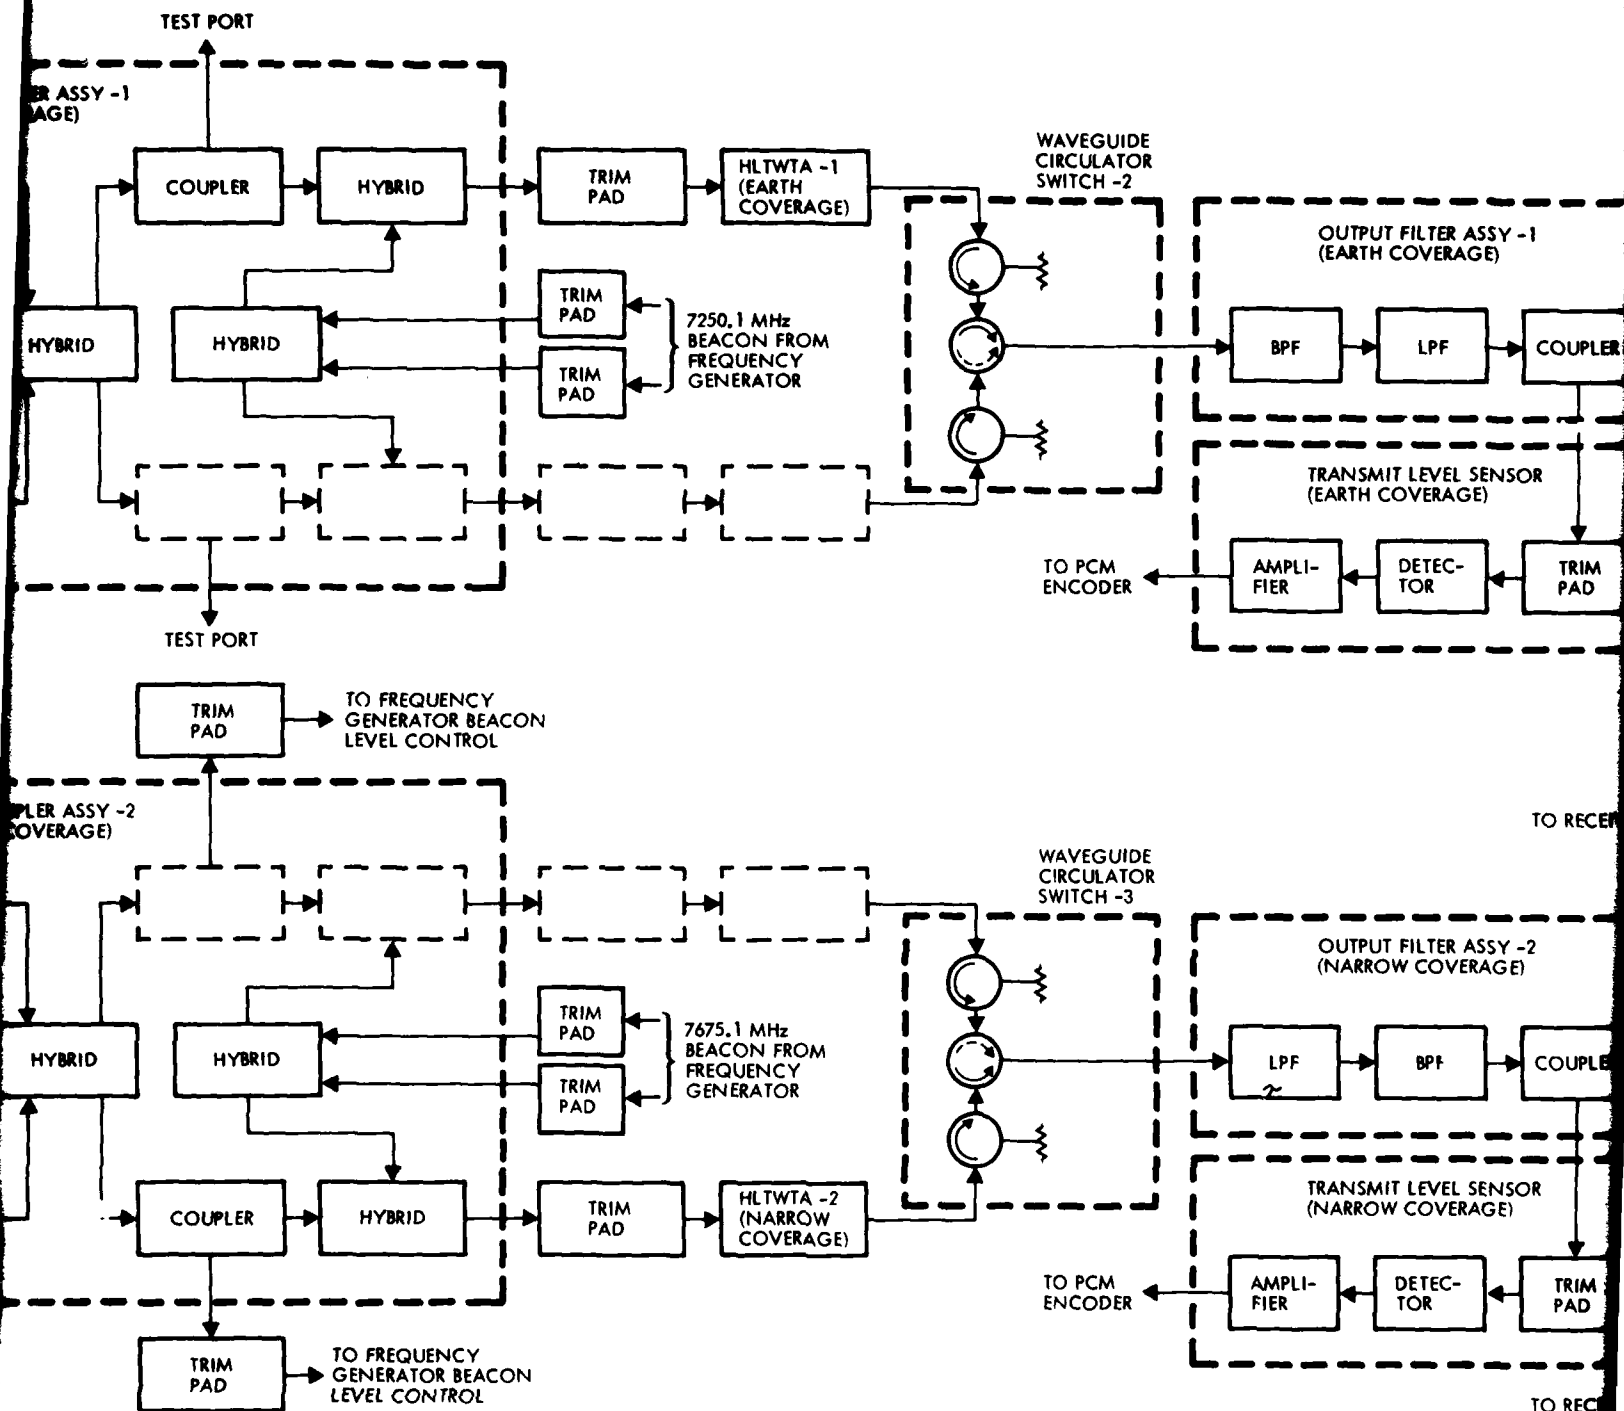
1.1-2. Communications Transmitter Section

NOTE: CIRCULATOR SWITCHES ARE CONTROLLED BY COMMANDS USED TO TURN HLTWTA'S ON AND OFF.

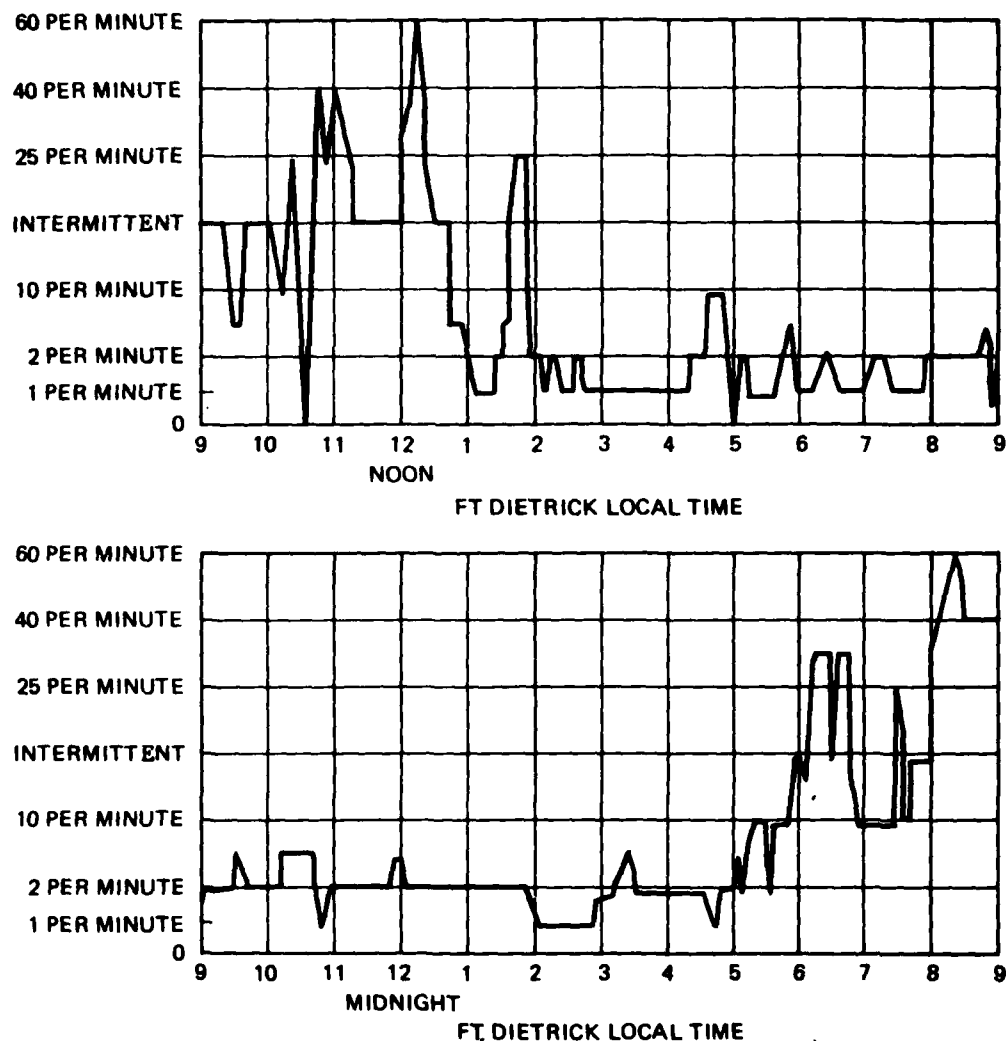
Figure 3.1-1. Typical Noise Pulses During One Day (19 & 20 March 81)

Another activity for on-orbit analysis was a correlation analysis of the continuously recorded RF output signal. This analysis covered about 30 days of data taken over a period of two months. The data was plotted in a format shown in Figure 3.1-1, which is a typical day.

An attempt was made to correlate spiking activity with time-of-day but no pattern could be discerned. However, it was clear that the number of spikes occurring each day was slowly decreasing as a function of time. At the end of two months, the spiking rate was significantly lower than at the beginning. This phenomenon will be discussed in more detail in Section 4.

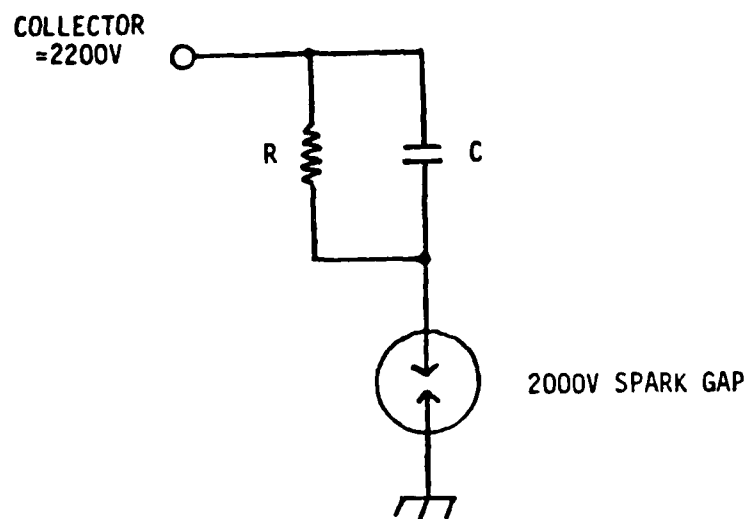
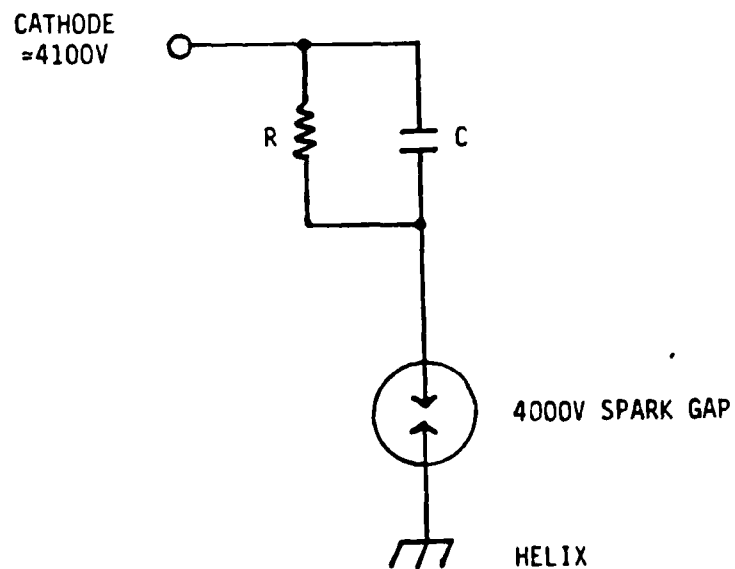
Figure 3.2.3.1-1 Spark Test Configuration

- (a) Cathode Circuit Experiment. With the spark gap circuit of Figure 3.2.3.1-1B in place on the TWT cathode lead, the unit was operated while observing the telemetries and RF output on the strip chart recorder. Various values of capacitance from 0.001 to 0.01 μf were used to simulate different amounts of transferred charge. The effects on helix current (I_w) telemetry and RF output amplitude were particularly noted. The closest match to orbital symptoms was obtained with 0.01 μf .

(b) Collector Circuit Experiment. The collector spark test was conducted similarly to the cathode test with only the change in spark gap voltage rating as shown in Figure 3.2.3.1-1A. The capacitors used in the collector test varied from 0.01 to 0.1 μ f. Again the preferred value was 0.01 μ f.

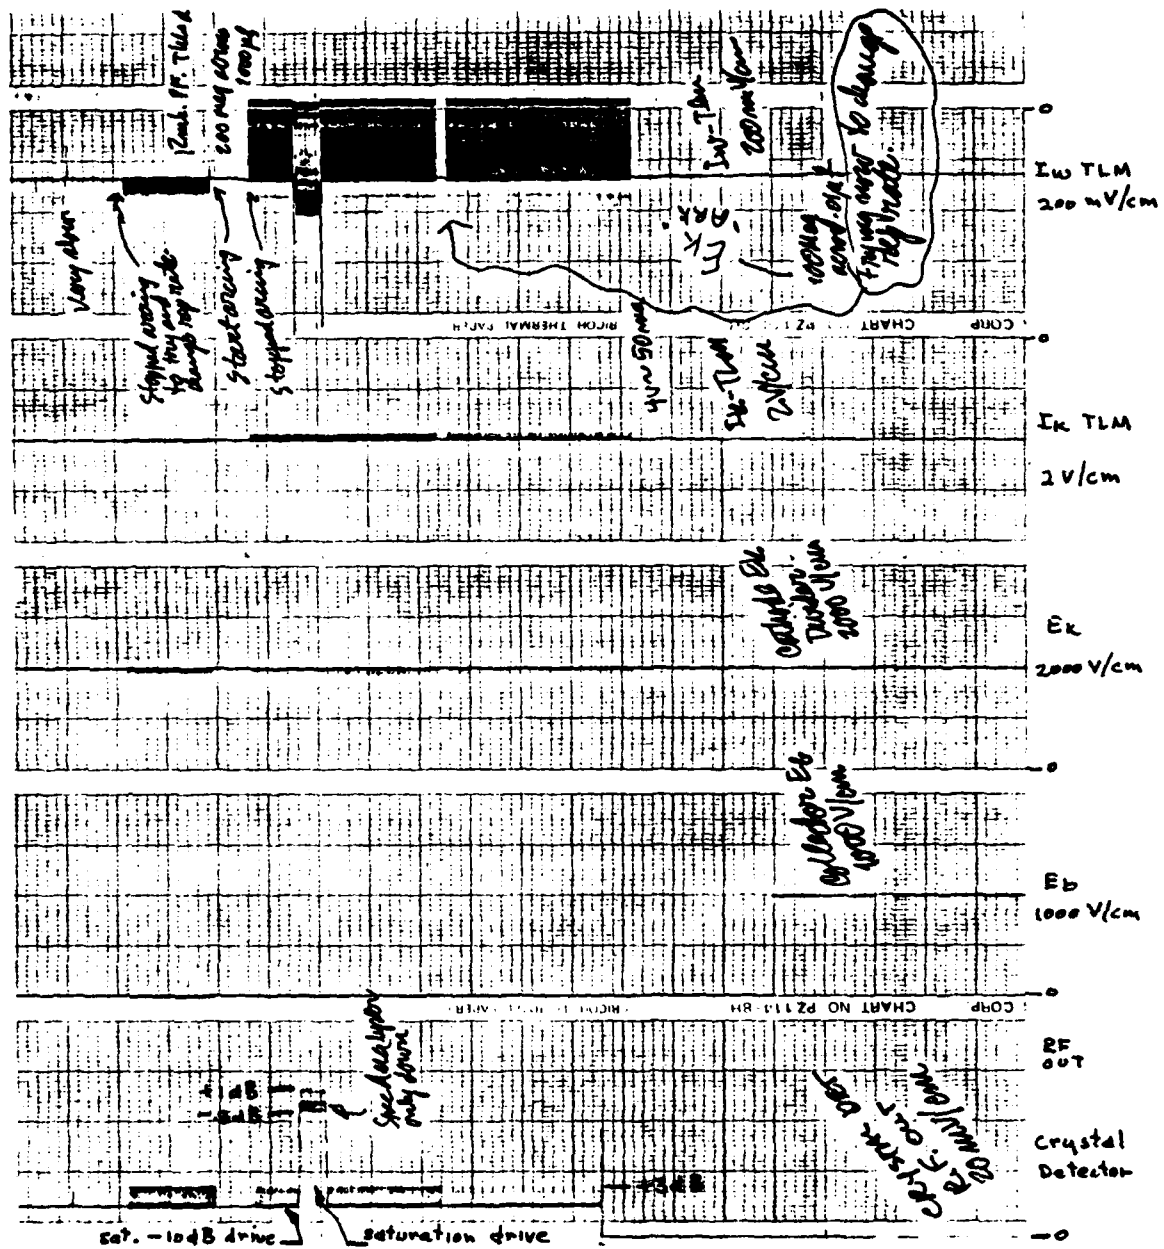
Figure 3.2.3.1-2. Cathode Spark Strip Chart

amplitude shift varied from plus 1 dB to -0.8 dB during saturation and up to plus 3 dB with saturation minus 10 dB drive. The helix current showed negative transients similar to the on-orbit data. A typical section of the strip chart recording is shown in Figure 3.2.3.1-2. The true amplitude of the spikes was likely somewhat less than that indicated from the strip chart. Some ground loop coupling from the spark current source through the crystal detector output may have occurred.

Two other tests were made to corroborate the data from the strip chart. A spectrum analyzer was used as an amplitude detector with the horizontal axis acting in time scan. A typical waveform photograph is shown in Figure 3.2.3.1-3. From the analyzer photo, we see that the negative excursion occurs first and is very narrow. The positive excursion has a much greater time duration though lower in peak amplitude. The phase variation of the RF during the spark was also measured and is shown in Figure 3.2.3.1-4B. Phase waveforms for both the cathode circuit spark and the collector circuit are shown together for comparison. Note that for the cathode spark, the initial phase peak was of short duration followed by a long recovery period.

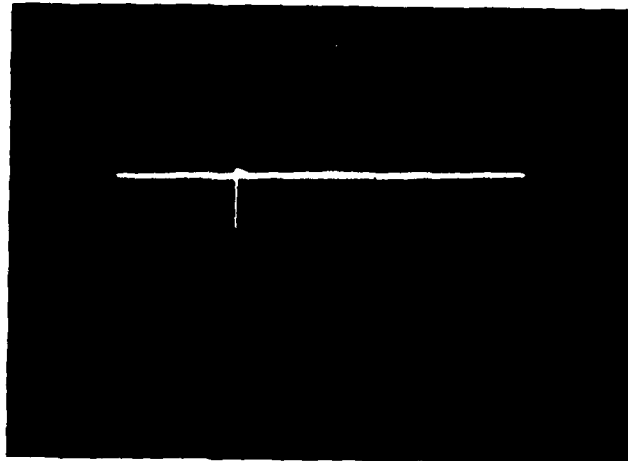
Figure 3.2.3.1-3. RF Amplitude Waveform from Spectrum Analyzer

The data from this test was a close match to that observed on orbit.

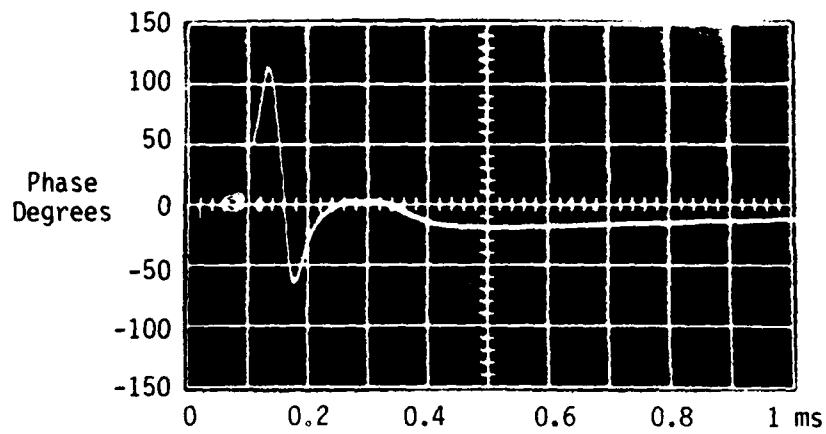
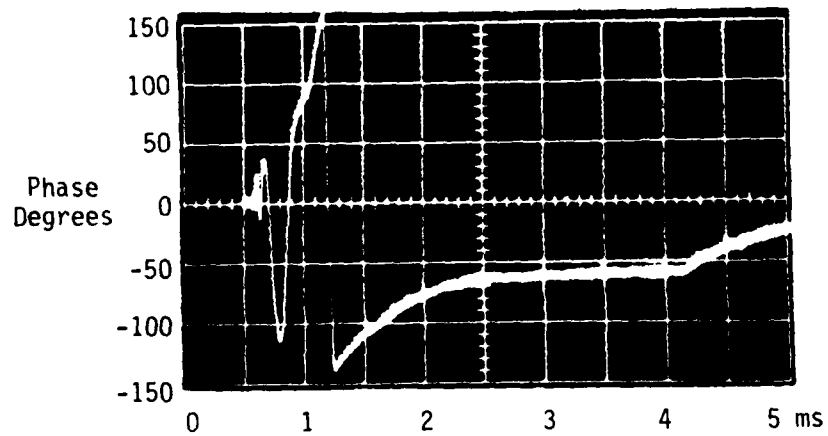
Figure 3.2.3.1-4A. Collector Spark RF Phase Transient

Figure 3.2.3.1-4B. Cathode Spark RF Phase Transient

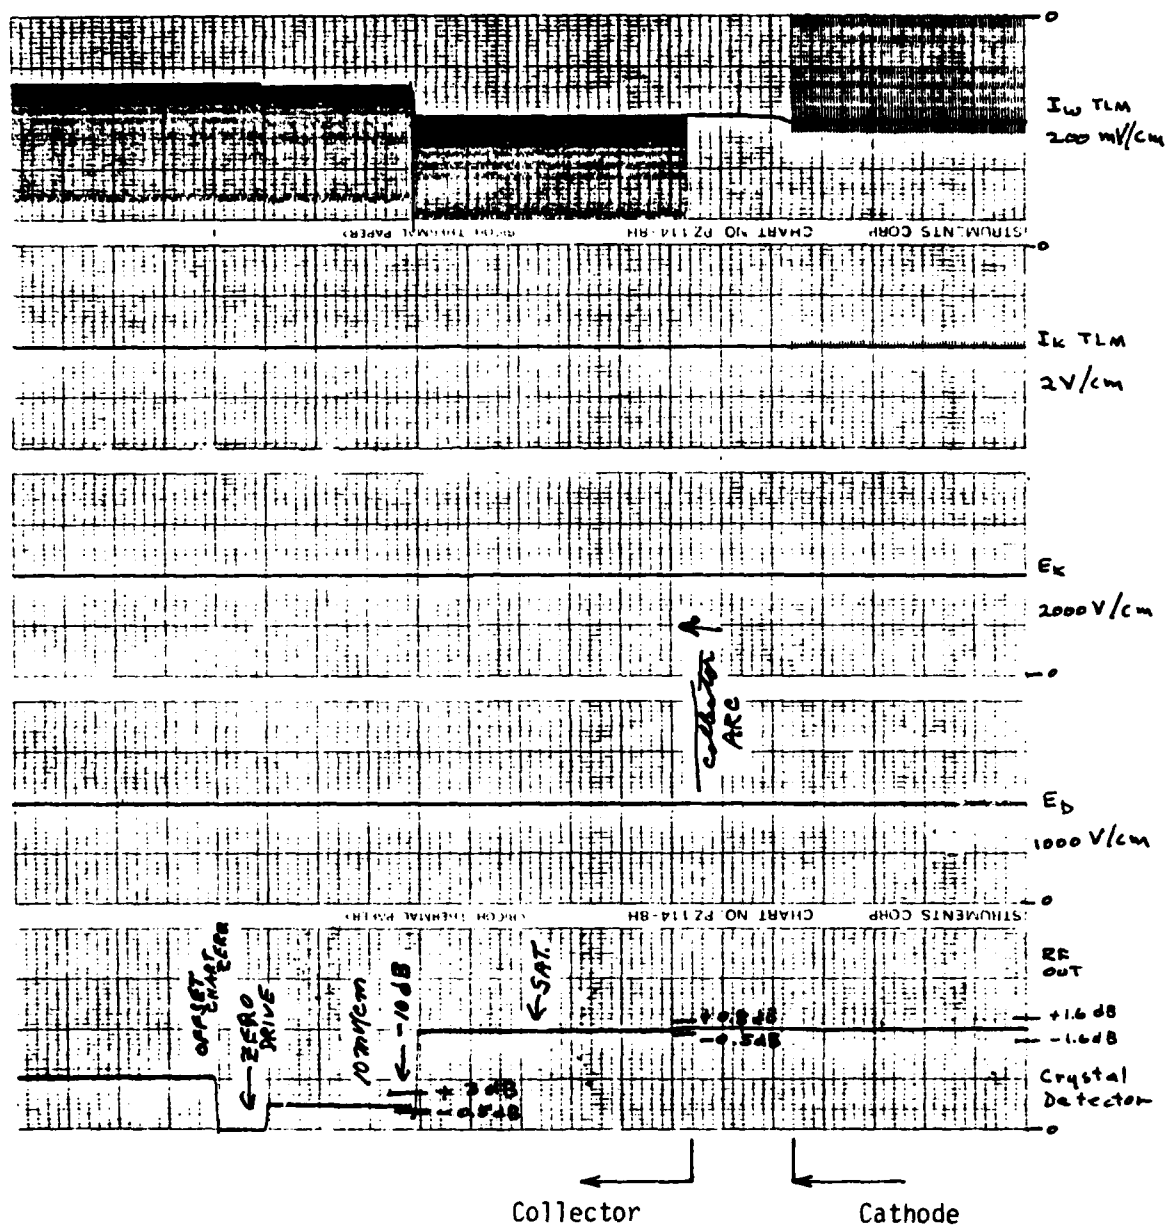
Figure 3.2.3.1-5. Collector Spark Strip Chart
with Cathode Spark Data Comparison

It is a peculiarity of this power supply that abrupt changes in tube voltages tend to produce reversed polarity or drops to zero in the helix current telemetry. The strip chart readings show this effect markedly at this capacitor value, with zero or low helix current indication at each spike. This effect can be seen in the results of arcing at cathode and collector, and is not diagnostic of any specific condition.

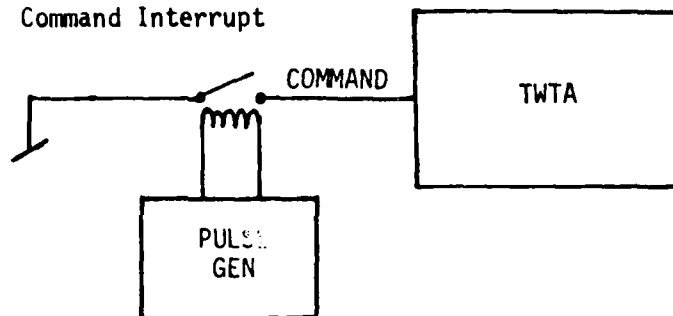
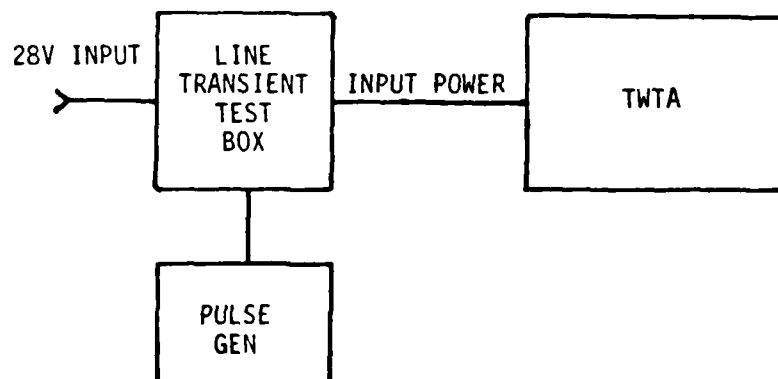
Figure 3.2.3.2-1. Interrupt Test Configuration

- (a) Command Interrup Test. With the breadboard EPC connected to the TWT and RF power applied, the command circuit was opened periodically using a fast operating relay as shown in Figure 3.2.3.2-1A.

- (b) Power Line Interrupt Test. The test setup for the 28 volt line interrupt experiment is shown in Figure 3.2.3.2-1B. Measurements were made similar to those described for the command interrupt test.

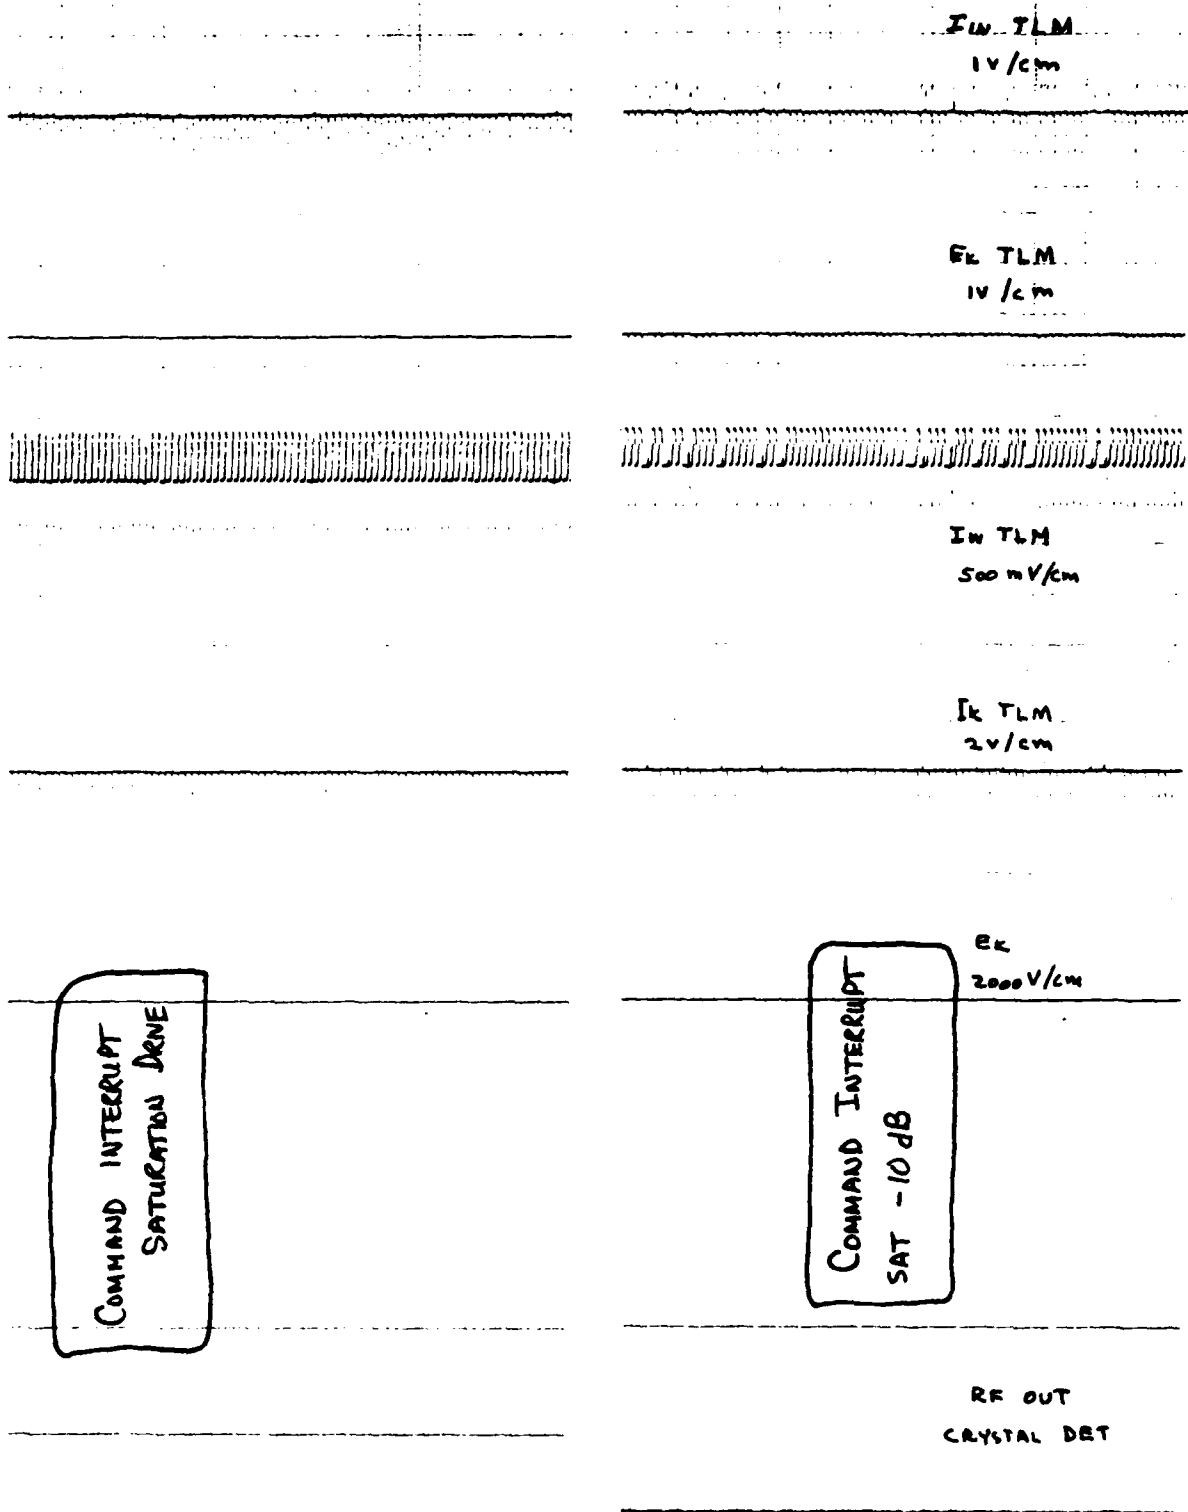
Figure 3.2.3.2-2.

Input current, TWT cathode voltage and current, helix current, and RF output power were monitored on a strip chart recorder. Typical results are shown in Figures 3.2.3.2-2.

Command Interrupt Test with RF
Saturated

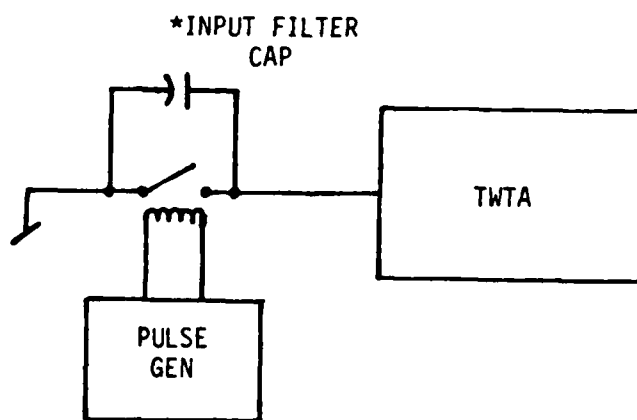
Figure 3.2.3.3-1. Shorted Filter Capacitor Test Configuration

An intermittent short circuit of one of the power line filter capacitors would cause a momentary decrease in input voltage to the main power converter of about 20%. This would be followed by a similar increase when the short was removed. These fluctuations, modified by the circuit response, would be reflected as changes in the TWT element voltages. An experiment was performed to determine if the modulation thus produced could cause symptoms similar to the orbital signature of TWTA S/N 24-1. The test configuration is shown in Figure 3.2.3.3-1 and the observed data are shown in Figure 3.2.3.3-2. The time axis is from right to left.

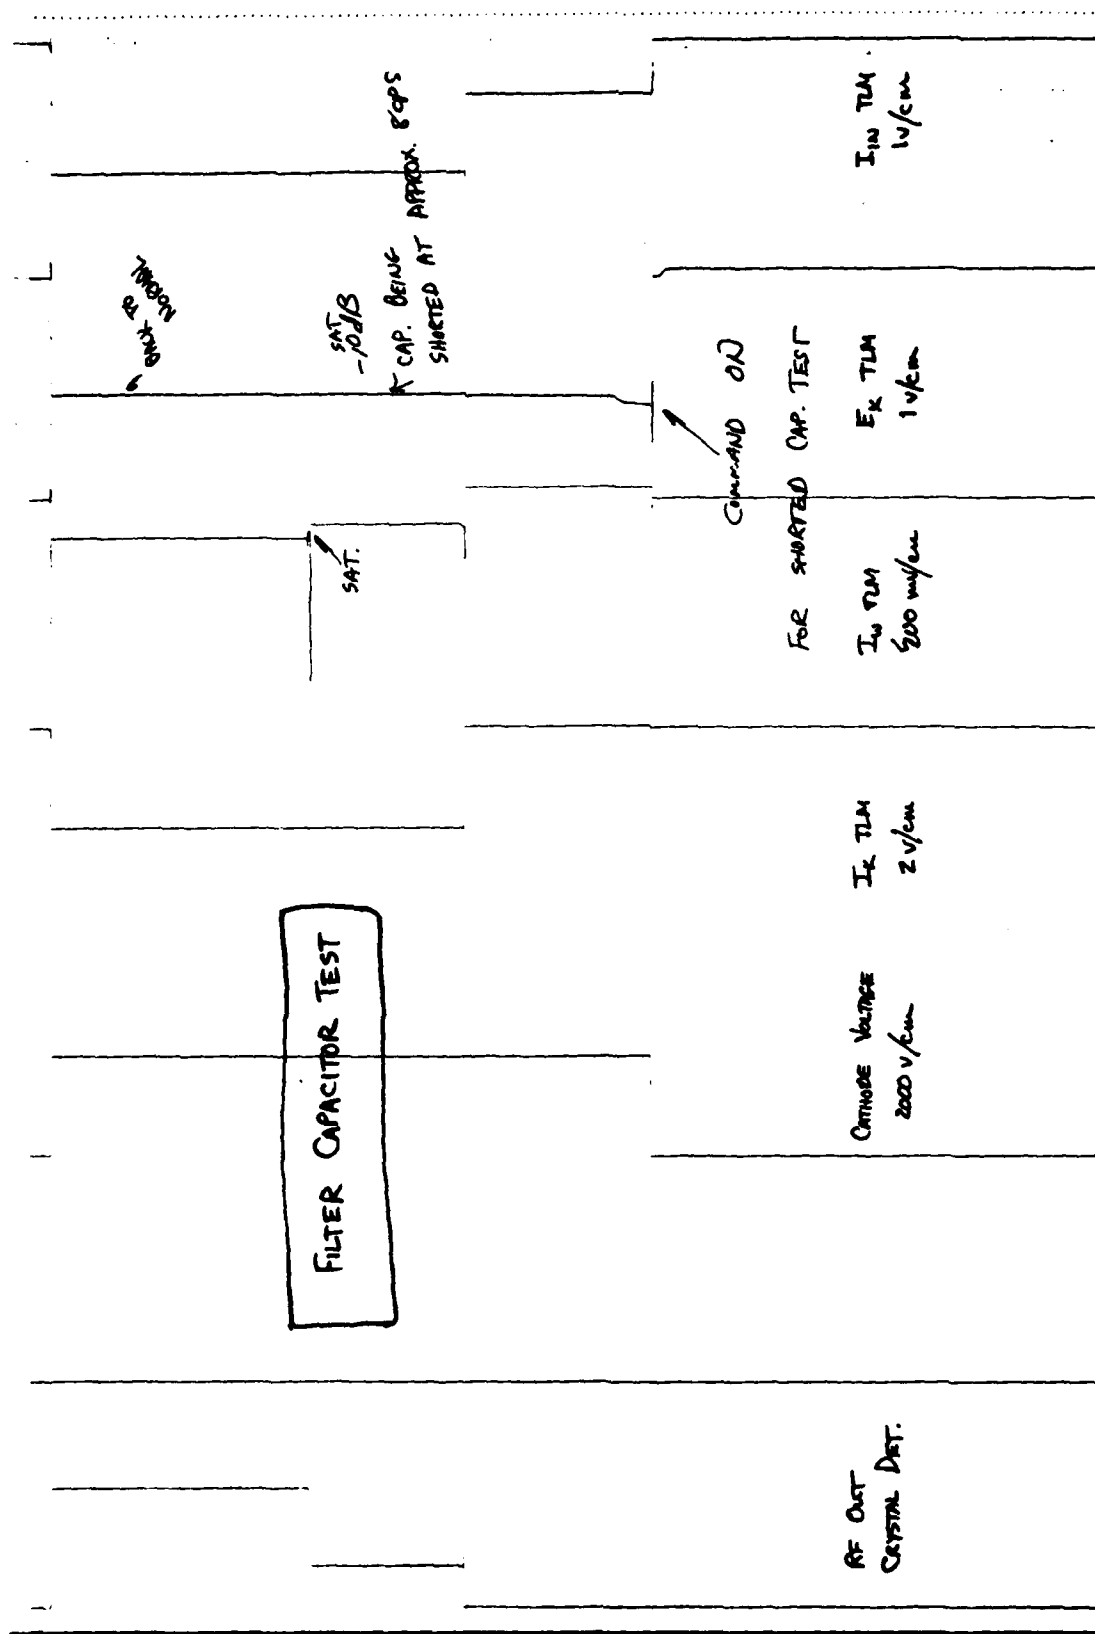
Figure 3.2.3.3-2. Filter Capacitor Test Data

Two conditions of RF output are shown; 10 dB below saturation and saturated. The RF output is seen to be effectively unperturbed by the intermittent short for either level of drive. It is concluded that this could not be the mechanism of failure for 9443.

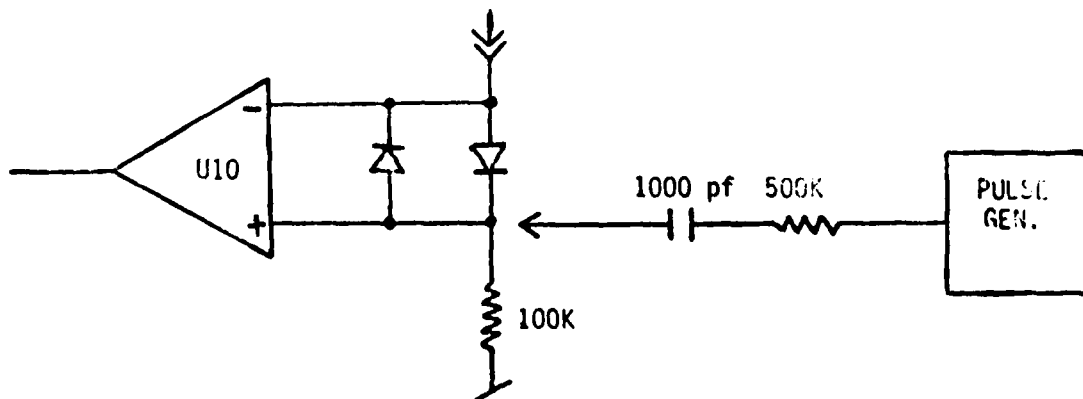
Figure 3.2.3.4-1. Helix Regulator Test Setup

The experiment test setup is shown in Figure 3.2.3.4-1. Figure 3.2.3.4-2 shows the helix regulator schematic diagram illustrating the test signal input and the regulator output monitoring point.

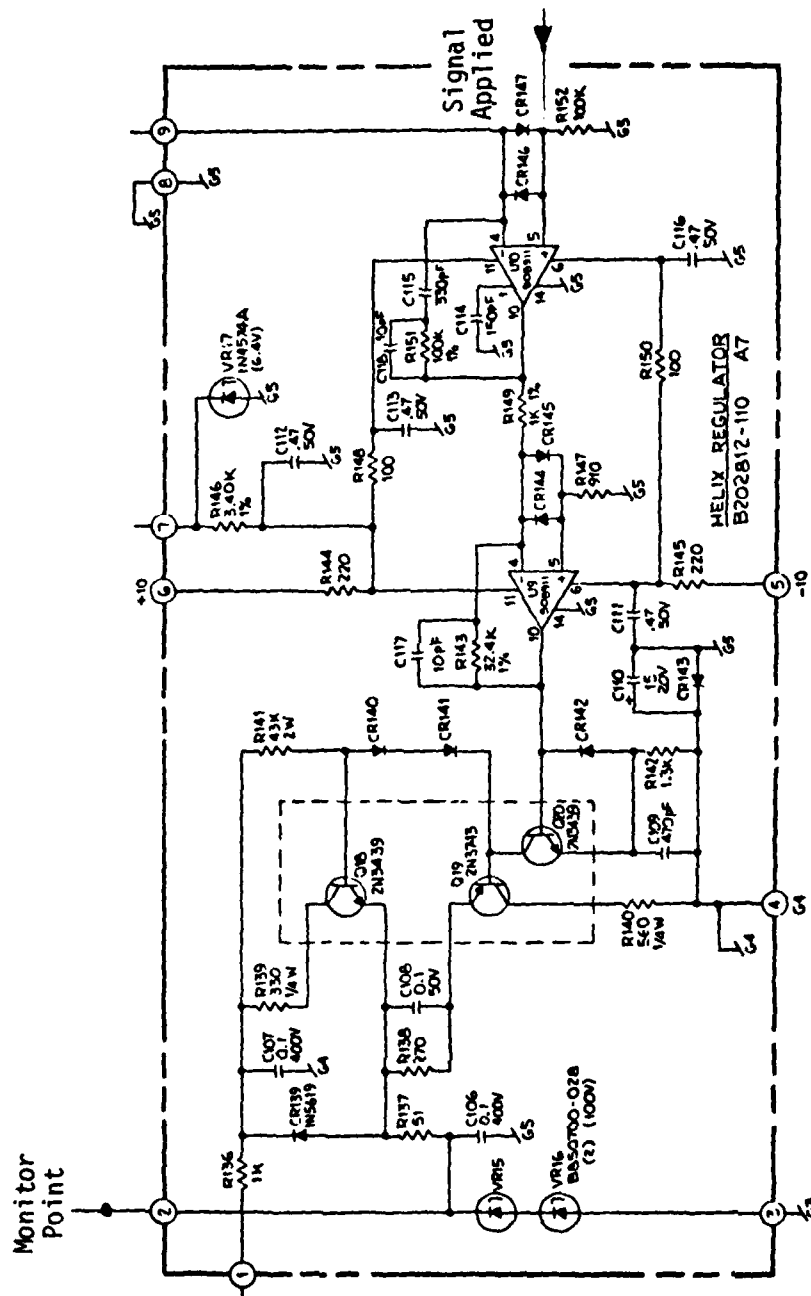
Figure 3.2.3.4-2. Helix Regulator Schematic

The output of the regulator, observed at the "monitor point" of Figure 3.2.3.4-2, may be seen in Figure 3.2.3.4-3. A negative swing of 80 volts is followed by a positive recovery swing of 50 volts. The corresponding RF output pulse, for drive 10 dB below saturated value, may be seen in the waveform photograph of Figure 3.2.3.4-4. The RF envelope was obtained through a spectrum analyzer set for 300 kHz bandwidth with a 20 ms/cm scan rate. The waveform is seen to be of about one dB peak amplitude and to have a wave shape similar to the voltage output of the regulator. A strip chart recording corresponding to the photographs of Figures 3.2.3.4-3 and 3.2.3.4-4 is shown in Figure 3.2.3.4-5 which compares the results during RF saturation with those for RF drive reduced 10 dB.

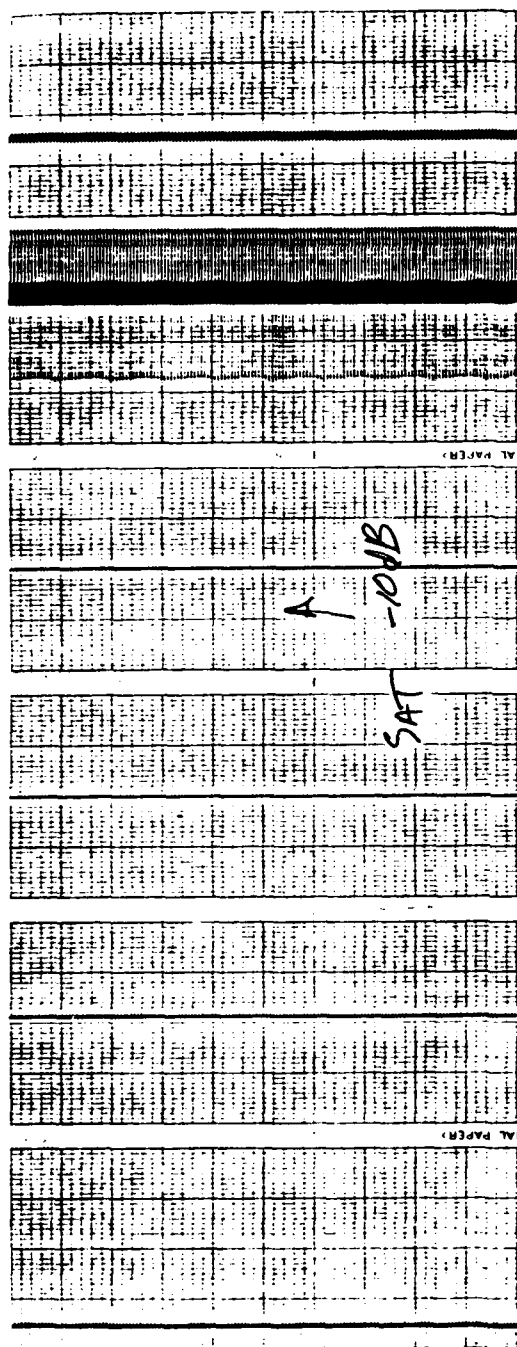
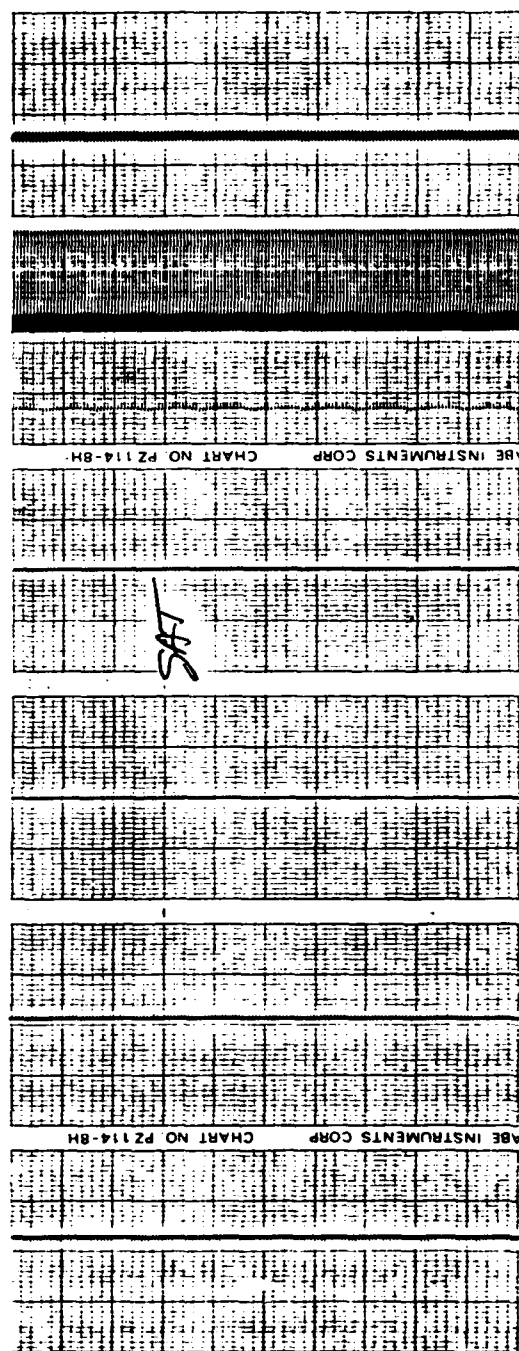
Figure 3.2.3.4-5

It is noted that perturbations of the order of 1 to 2 dB may be seen in the RF output. The match to the orbital signature, however, is not satisfactory because the downward swings are more prominent than the upward swings. While it is probable that the spacecraft output pulses did include negative swings, they were of such short durations that they were not recorded by the chart recorders at Ft. Monmouth. The similarity of positive and negative recovery characteristics of the regulator preclude a very fast negative transient followed by a long positive recovery.

Helix Regulator Test Strip Chart,
10 dB Below RF Saturation

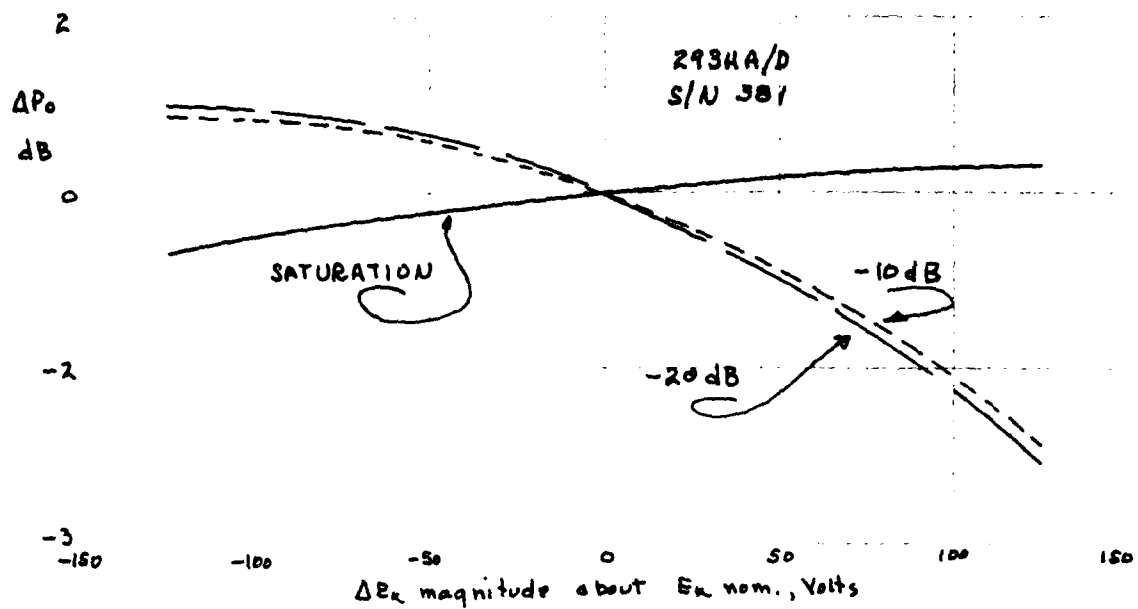
Figure 3.2.3.5-1. RF Power Output Variations About the Nominal Value For Three Levels of Power Output Vs Changes in E_k Magnitude

- (a) Amplitude Sensitivity. RF power output for the TWT was measured as a function of variations in cathode voltage and anode voltage for constant input power. The input power reference was that required to saturate the tube at nominal E_k and E_a . For the saturation curves, the input power was held constant while the element voltages were varied. For the small signal curves, the input power was reduced 10 dB and 20 dB, respectively, from the saturation value determined above and held constant for the duration of the tests. Curves for the output power variation with cathode voltage are shown in Figure 3.2.3.5-1. Similar curves for the anode voltage change is shown in Figure 3.2.3.5-2. The curves for the three drive levels are superimposed. The change in output is expressed in dB and the absolute output in dBm has been subtracted out to yield 0 dB for the nominal value in each case. In this way, the relative characteristics can be easily compared.

Two phenomena are observable in the curves. Small signal gain dependence is seen in the curves at 10 and 20 dB down from saturation. Variation in saturated power output, with constant input drive power, is also in evidence. The results show that for the 293HA TWT, there is a total variation of +0.3 dB for increases in cathode voltage of 125 volts to -0.7 dB for a similar decrease in voltage. For small signal condition, the gain is seen to vary from -2.5 dB for the increase in cathode voltage to +1.0 dB for the corresponding decrease. Anode voltage variation

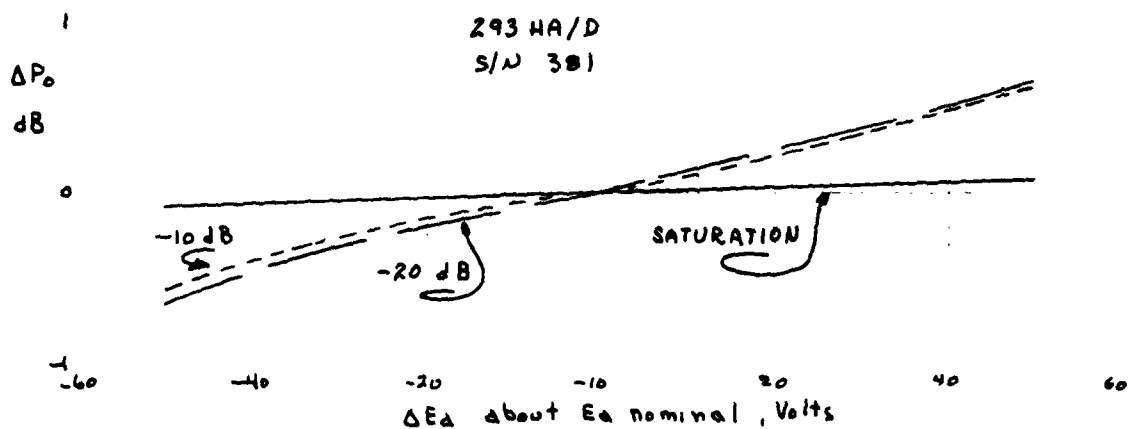
Figure 3.2.3.5-2. RF Power Output Variations About the Nominal Value For Three Levels of Power Output Vs Changes in E_a

curves show a similar pattern except for the magnitudes and a reversed sense for small signal gain dependence.
